ST. PAUL'S SCHOOL
2021 ASBESTOS 3 YEAR REINSPECTION

RPF File 21.0636

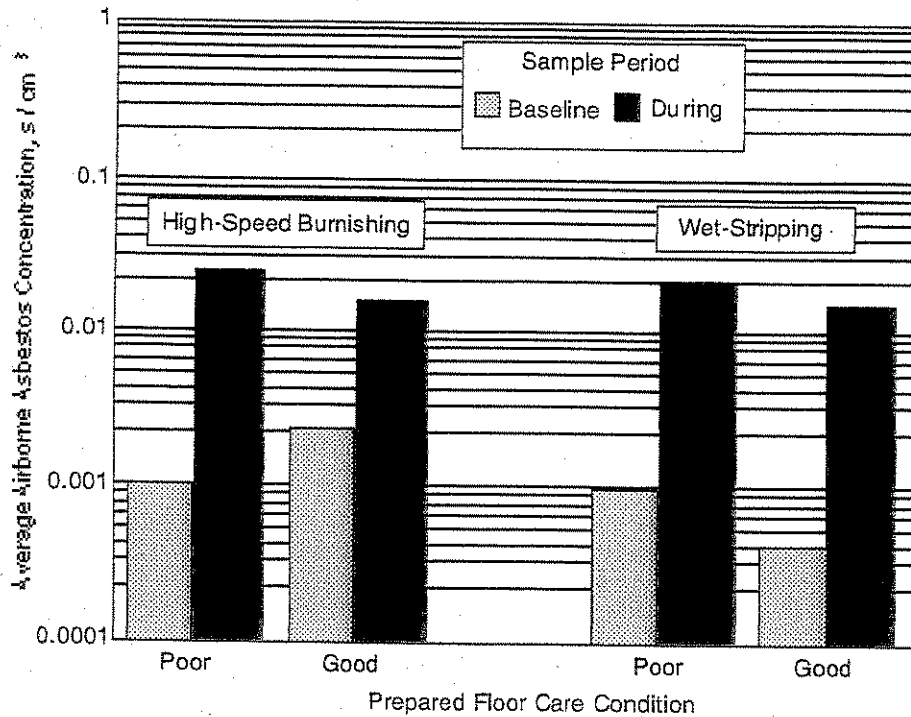
Figure 2. Average airborne asbestos concentrations measured before and during ultra high-speed burnishing and wet-stripping of floors in prepared conditions.

TWA concentrations measured during wet-stripping (after ultra high-speed burnishing) exceeded the OSHA PEL of 0.1 f/cm³ for total fibers, all of the 8-hr TWA concentrations measured during ultra high-speed burnishing exceeded the OSHA PEL. These exceedances, however, were due to the excess nonasbestos-containing particulate generated during the burnishing process and not to elevated airborne asbestos particles.
